AIRCRAFT ACCIDENT REPORT

In-flight Breakup Over the Atlantic Ocean
Trans World Airlines Flight 800
Boeing 747-131, N93119
Near East Moriches, New York
July 17, 1996

**NTSB/AAR-00/03
DCA96MA070
PB2000-910403
Notation 6788G
Adopted August 23, 2000**

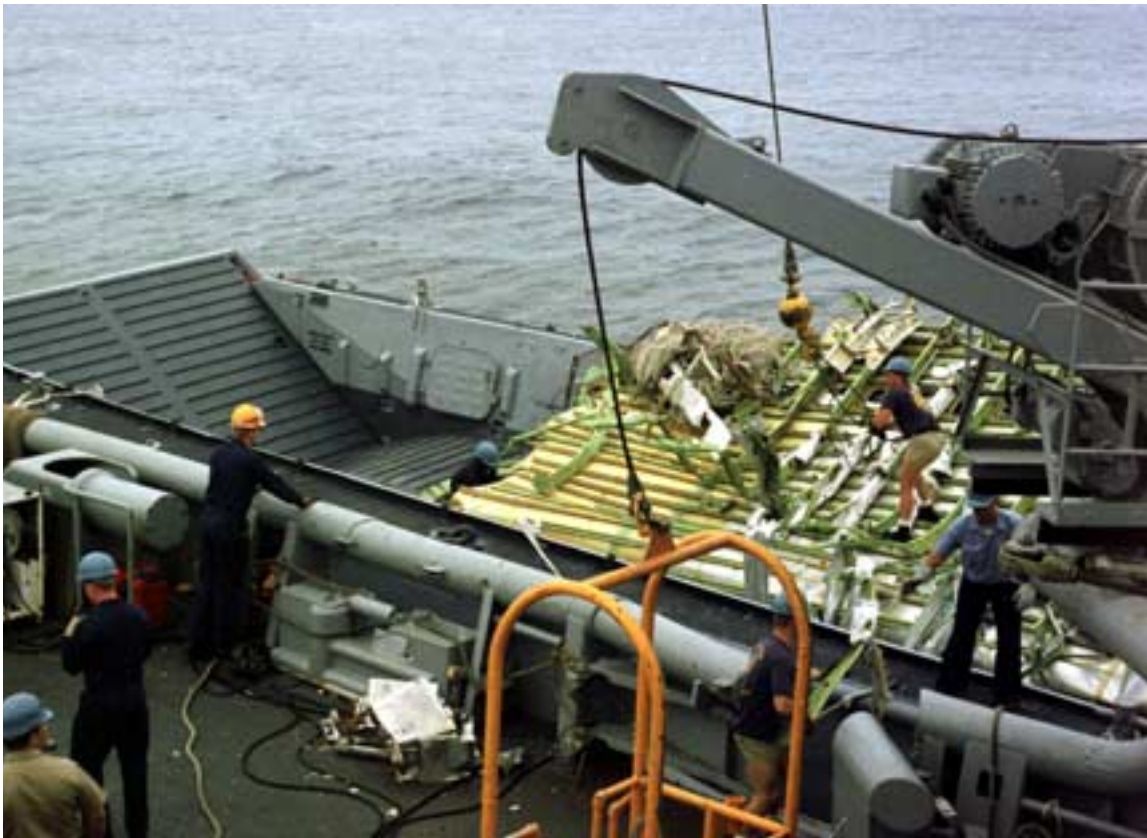
Figure 24. A photograph showing wreckage recovered with tangled and damaged wires attached.

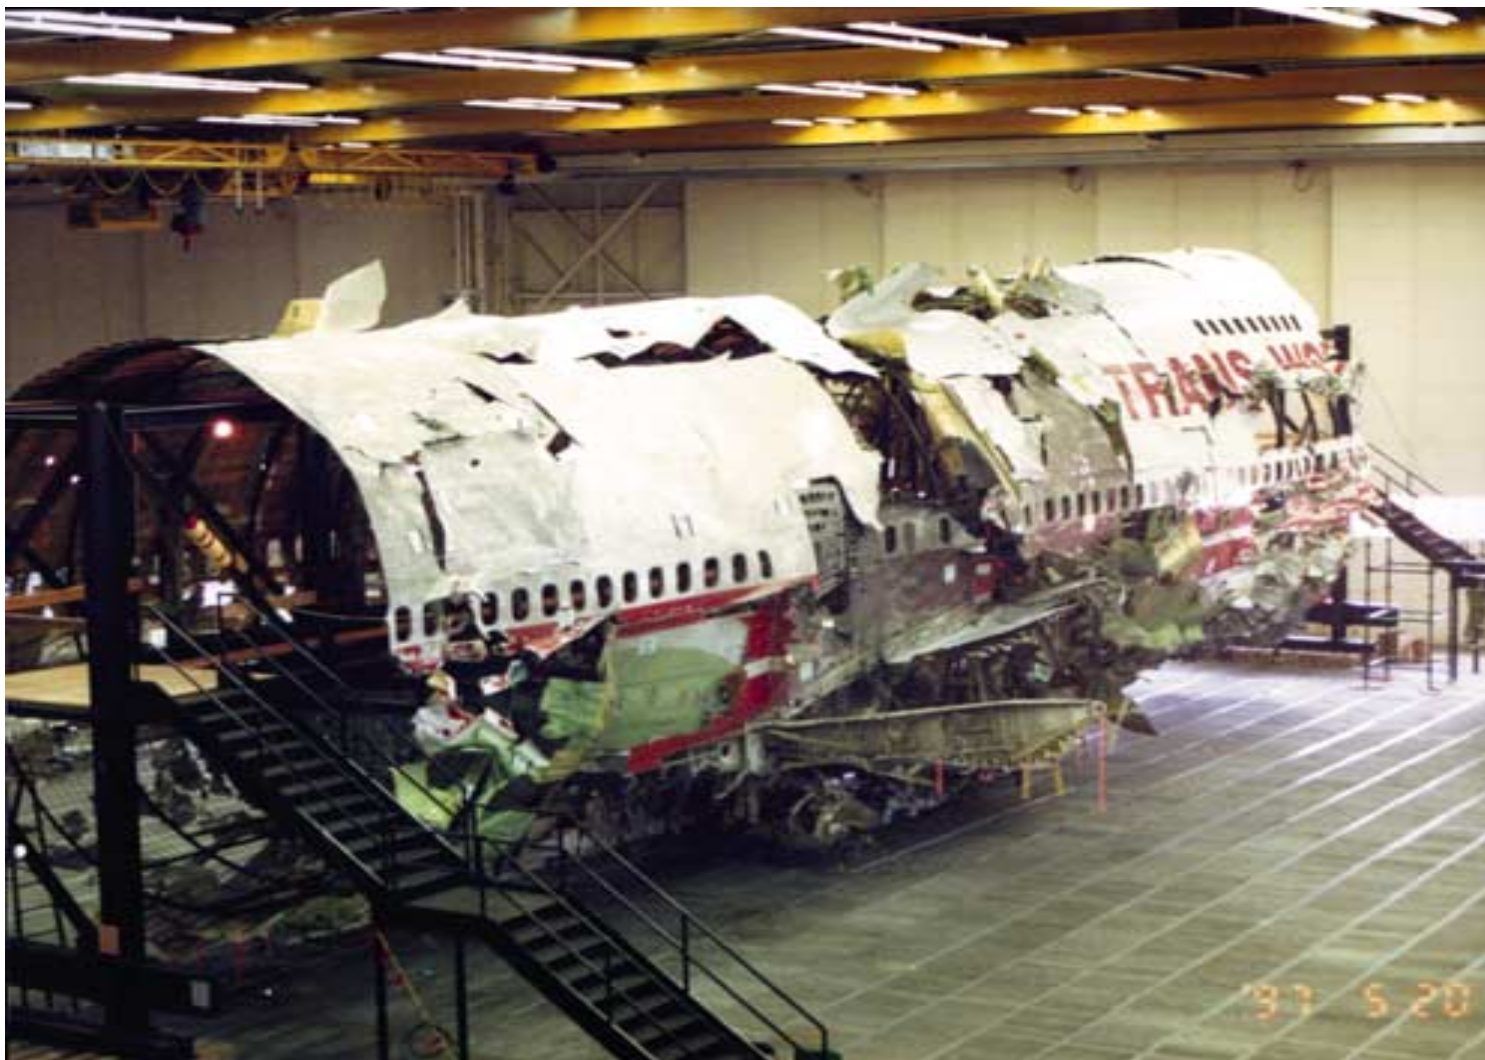
Figure 29. A photograph of the right side of the large three-dimensional reconstruction, with the support scaffolding visible.

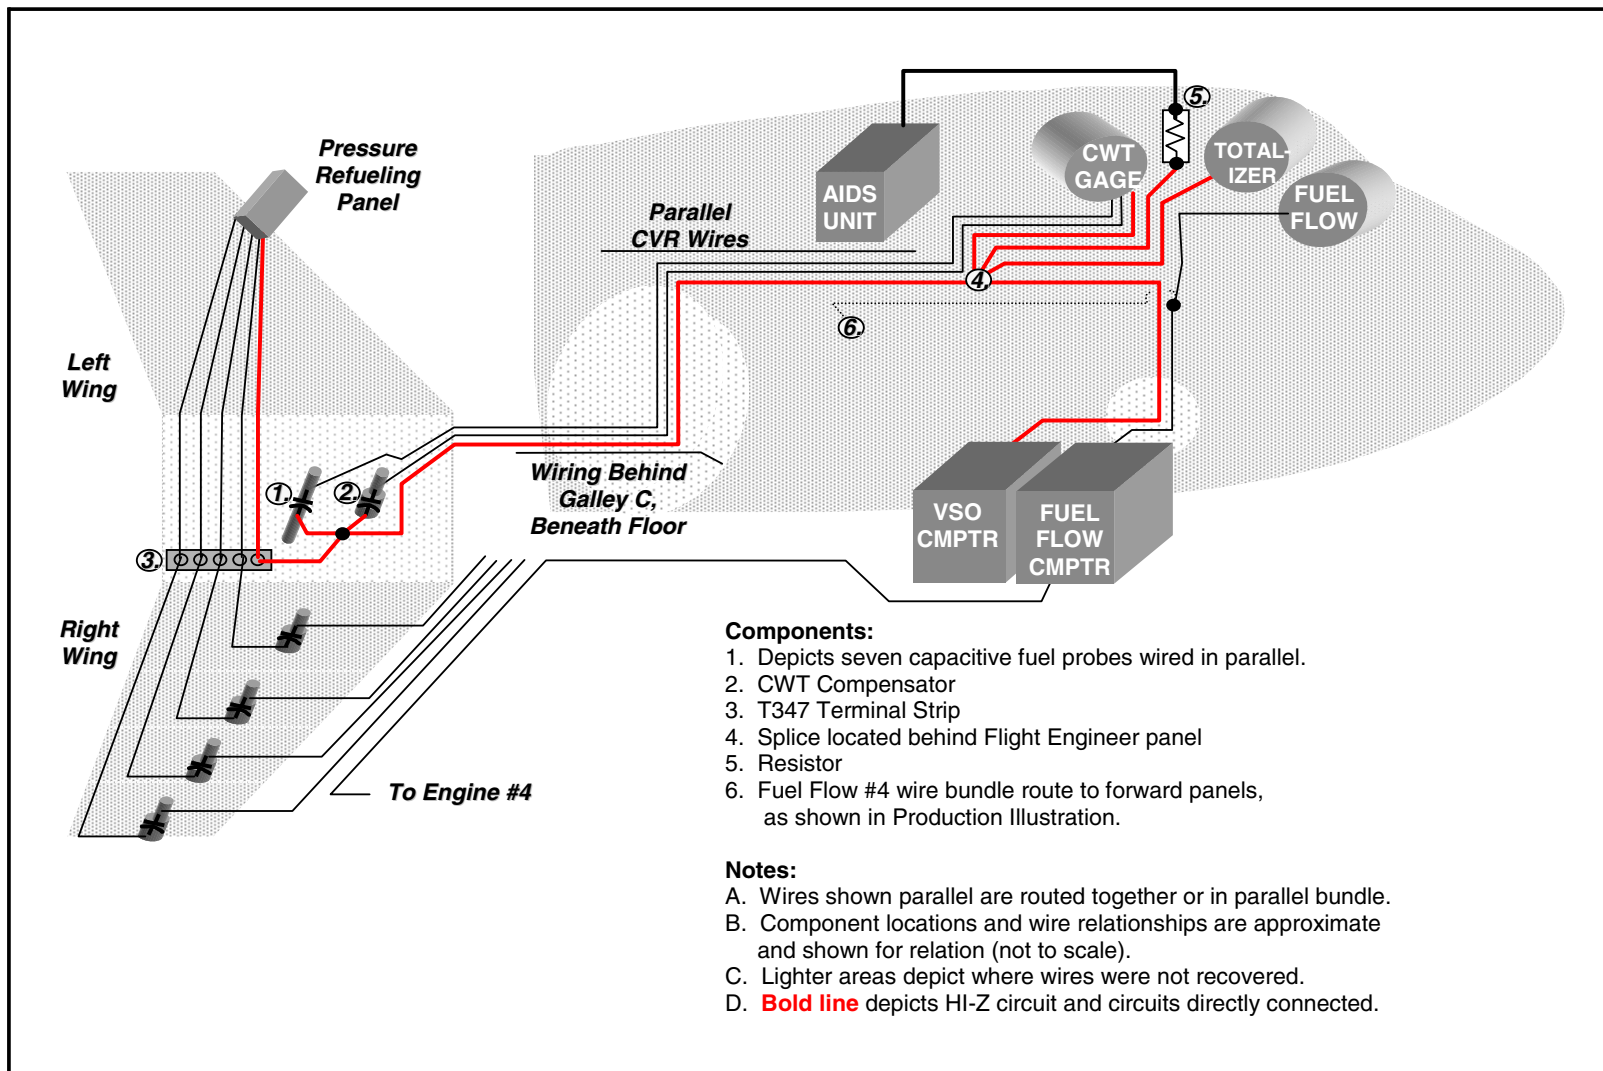
⁶⁰⁶ Testing conducted for the Safety Board by Lectromec demonstrated that current peaks of more than 100 amperes (amp), which released 2 to 4 J of energy (of which about 400 mJ could be transferred to a victim wire), could be produced on wires protected by 10-amp circuit breakers when short circuits were created by dripping either water or lavatory fluid onto damaged wires. (For more information about this testing, see section 1.16.6.2.)

Figure 46. Diagram of the center wing tank fuel quantity indication system wiring on the 747 and its common connectors.
